NASA Technical Memorandum 104059

# Structural Integrity of Wind Tunnel Wooden Fan Blades

Clarence P. Young, Jr., Robert T. Wingate, Kenneth W. Mort,  
James R. Rooker, and Harold E. Zager

April 1991

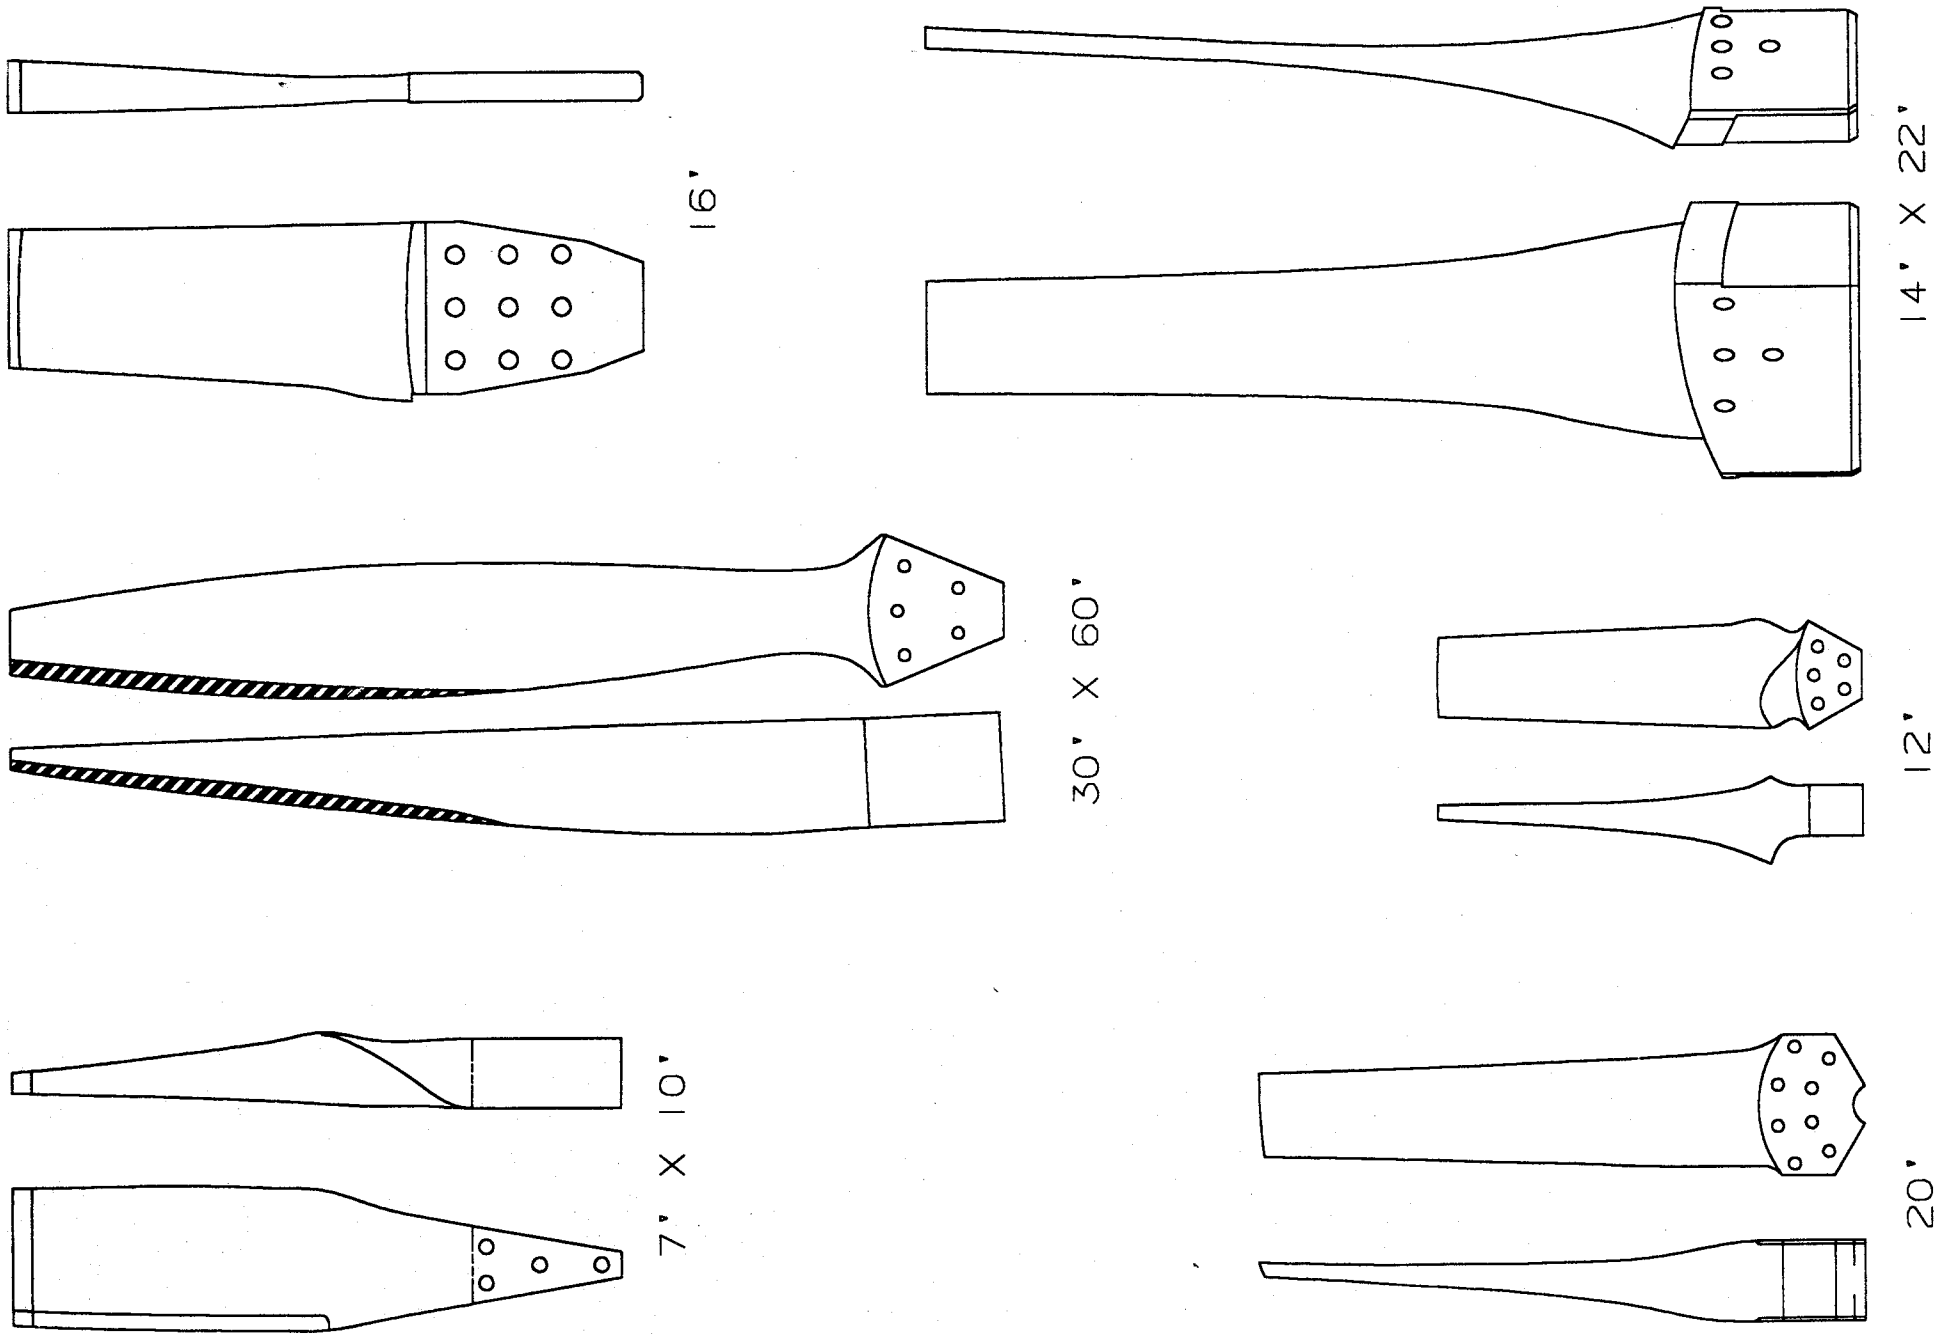
Figure 11. - LaRC Wind Tunnel Fan Blades Illustrating Hub Attachment Geometries

In addition to the attachment methods shown in figure 11, there are a variety of other hub designs and blade attachment methods. Generally, it has been found that for low blade loading (low stress) in the attachment region, no problems were encountered. However, failure experience indicates that for highly stressed blades, shear out or pull out of blades at the hub attachment has been the predominate failure mode. One of the chief factors appears to be the load distributions in the

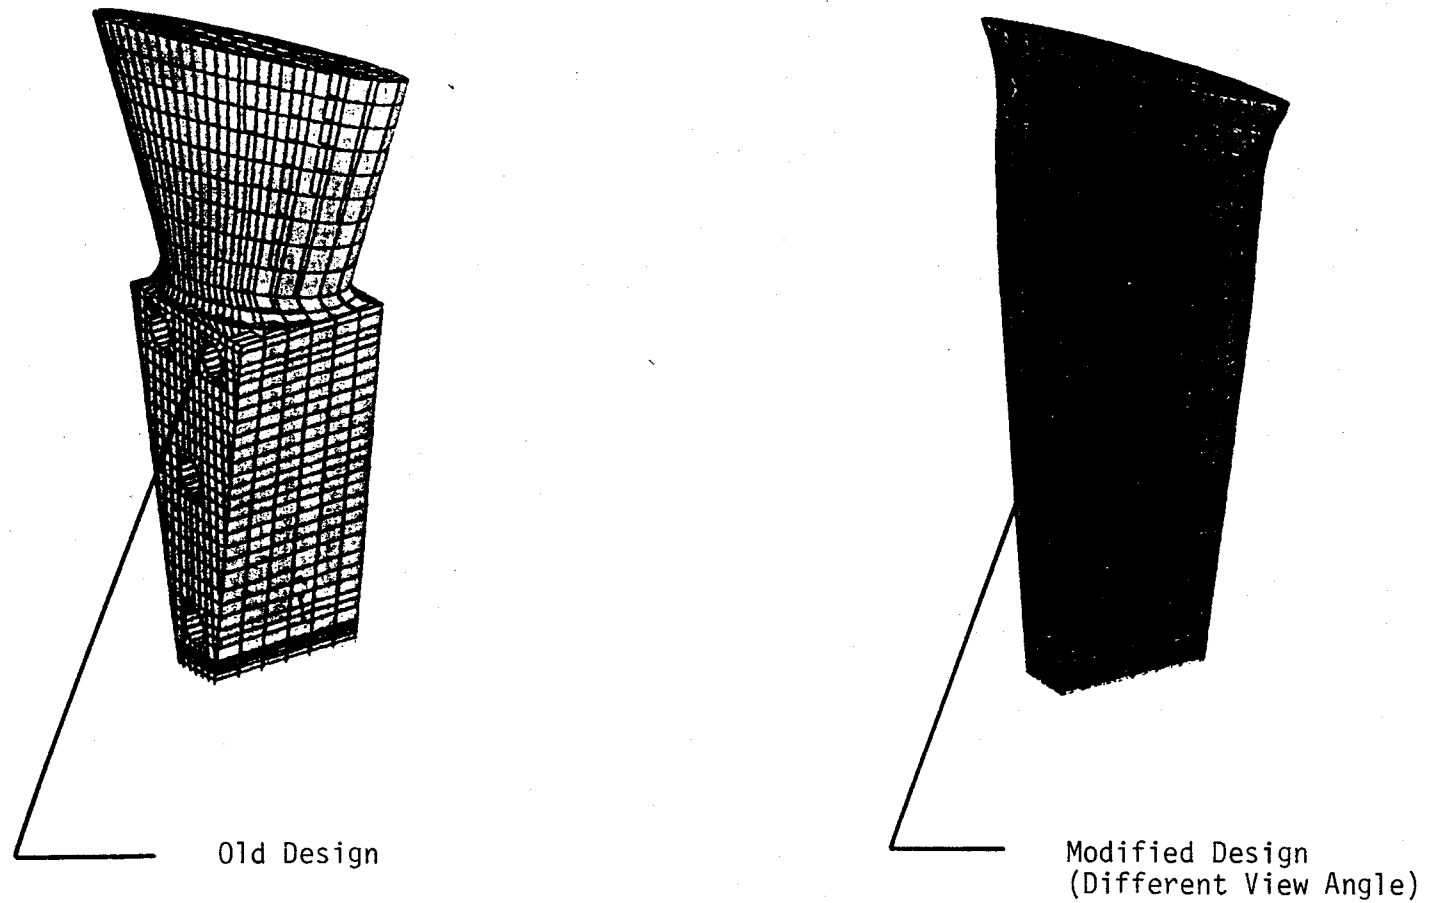
Figure 13. - Finite Element Models of the transition/butt regions for the NASA Langley Research Center 7- by 10-Foot wind tunnel fan blade.

The airfoil to root transition is based on a concern with the contour changes between the normally rectangular blade butt and the aerodynamic blade profile. If this transition consists of a gradual decrease in area from the blade butt to the blade profile, then the risk is low. However, if the transition occurs in a short length with the smallest cross-sectional area occurring between the blade butt and the blade profile, the risk is high. (Figure 13 shows the finite element model of the 7- by 10-Ft Wind Tunnel blades to butt transition which illustrated the short transition length and the redesigned transition.) This assessment is based on detail stress analyses performed at LaRC which indicate that for orthotropic wood properties the radial loads that exist at the smallest area do not uniformly spread out in the larger cross section area in the blade butt. Instead, these loads tend to remain concentrated in a small core region in the butt about the same as the smallest root area.

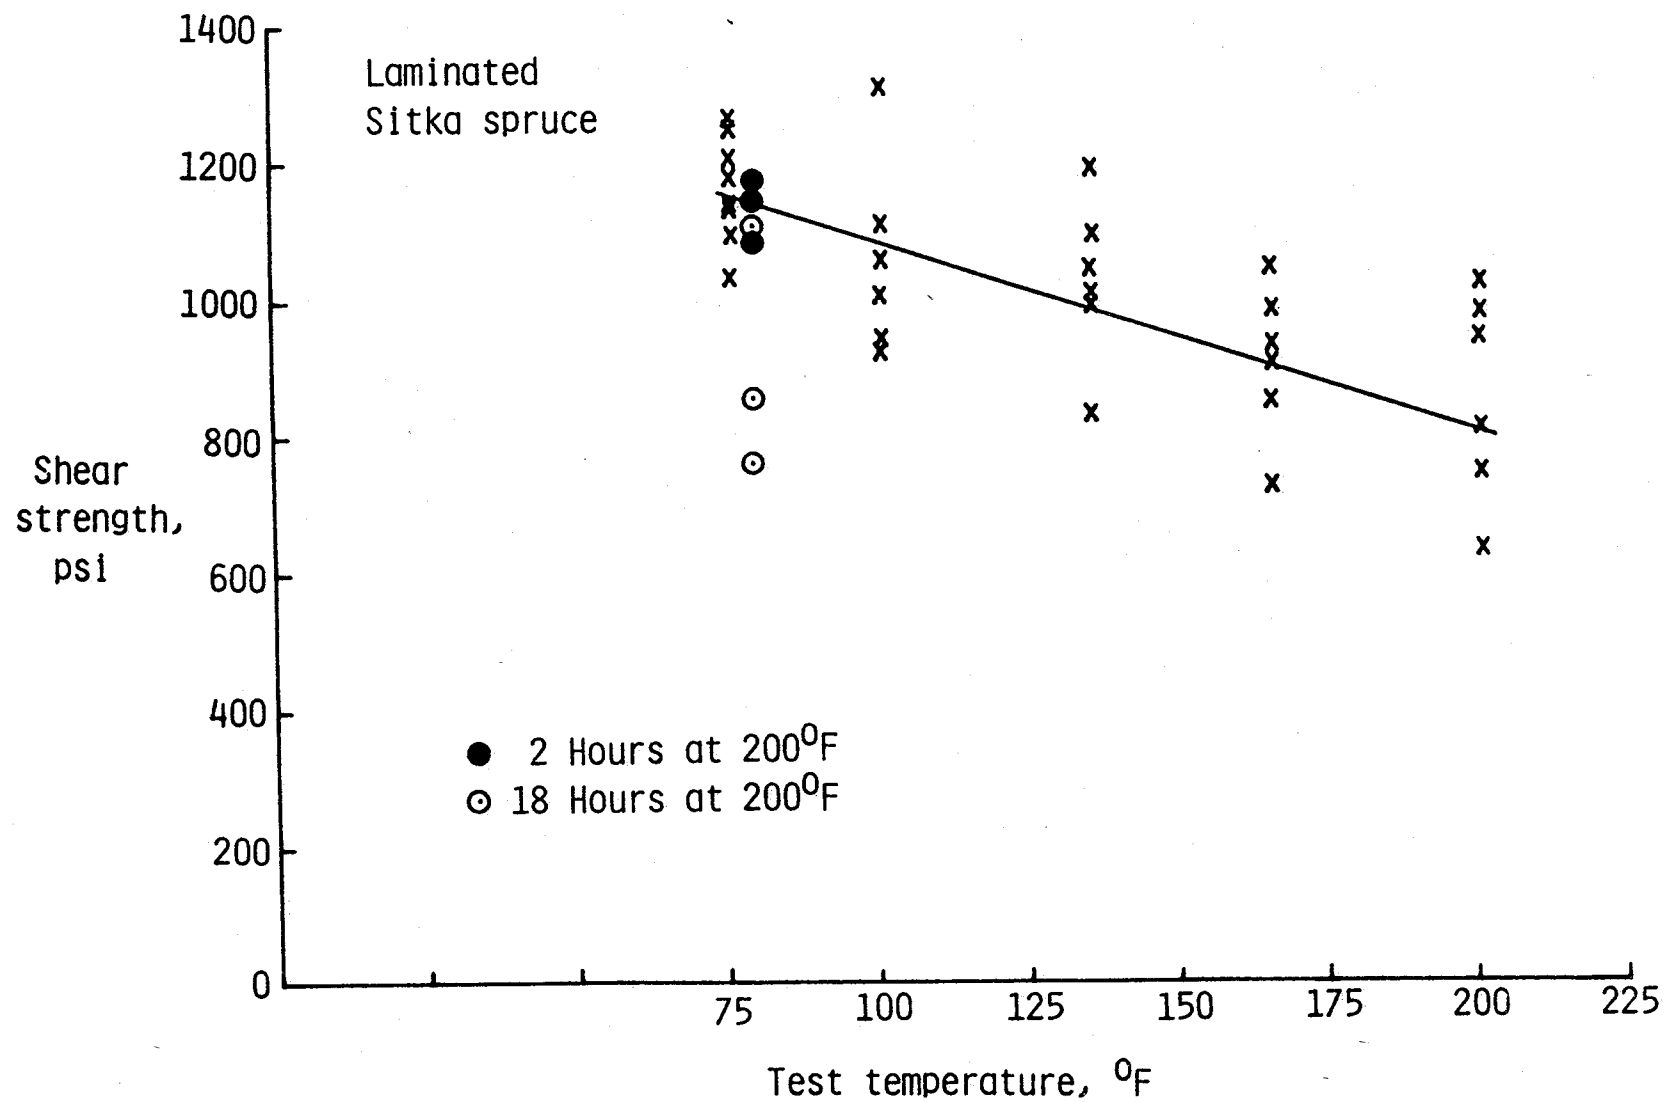
Figure 14.- Shear Strength of Laminated Sitka Spruce as a Function of Temperature.

There are no readily available, published data for Sitka Spruce at elevated or extremely cold temperatures; therefore, the procedure discussed in the next section was used to estimate the decrease in strength with temperature. Some elevated temperature shear strength and fatigue data for Sitka Spruce were developed at LaRC and are shown in figures 14 and 15. Also the material constants for both Sitka Spruce and densified wood are listed in figure 16 as used in LaRC's orthotropic analyses of its wooden fan blades.

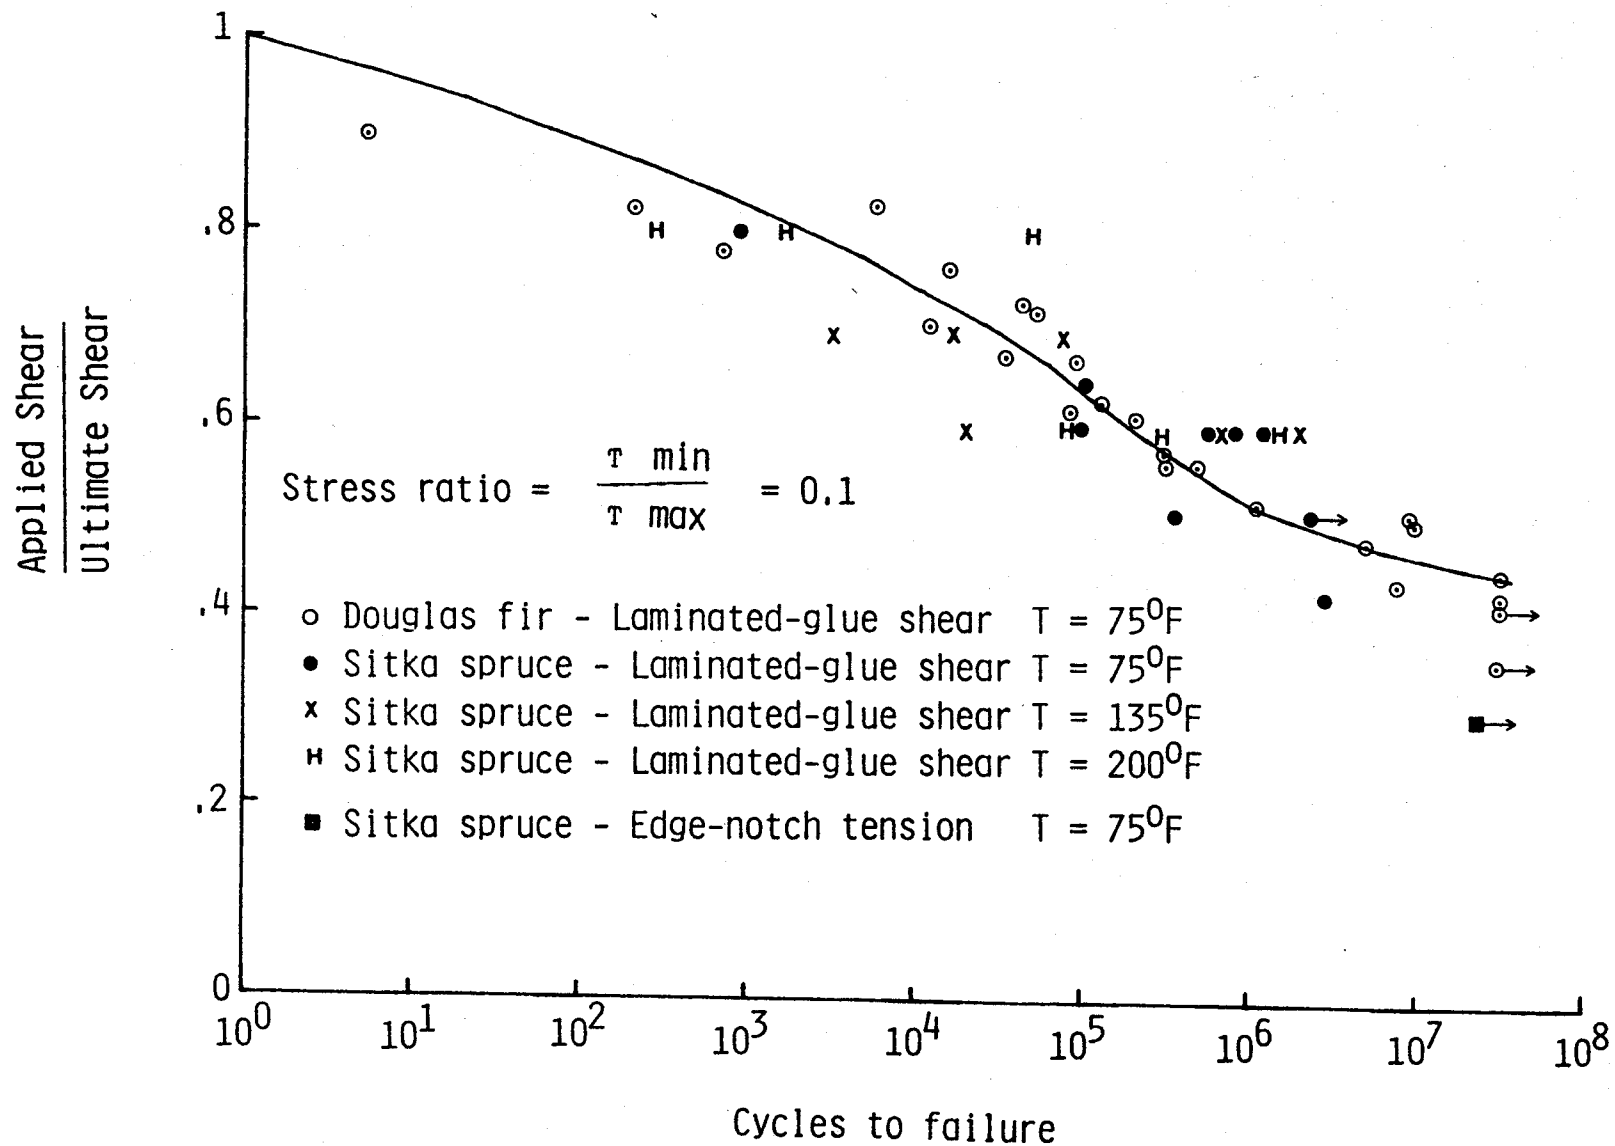
Figure 15. - Fatigue Strength of Laminated Sitka Spruce and Douglas Fir

Consideration of fatigue in the design of wooden structures is usually considered to be secondary. Fatigue tests have shown that the endurance limit for wood is generally around 40% of its static strength. In cases where the working stress levels are less than 40% of the wood strength (see fig. 15), fatigue is usually not a problem for most wood structures. However, local stresses if not properly accounted for in the wood near bolt or pin attach holes can exceed endurance limit stresses. For room temperature, the fatigue curves given in reference 8 can be used.

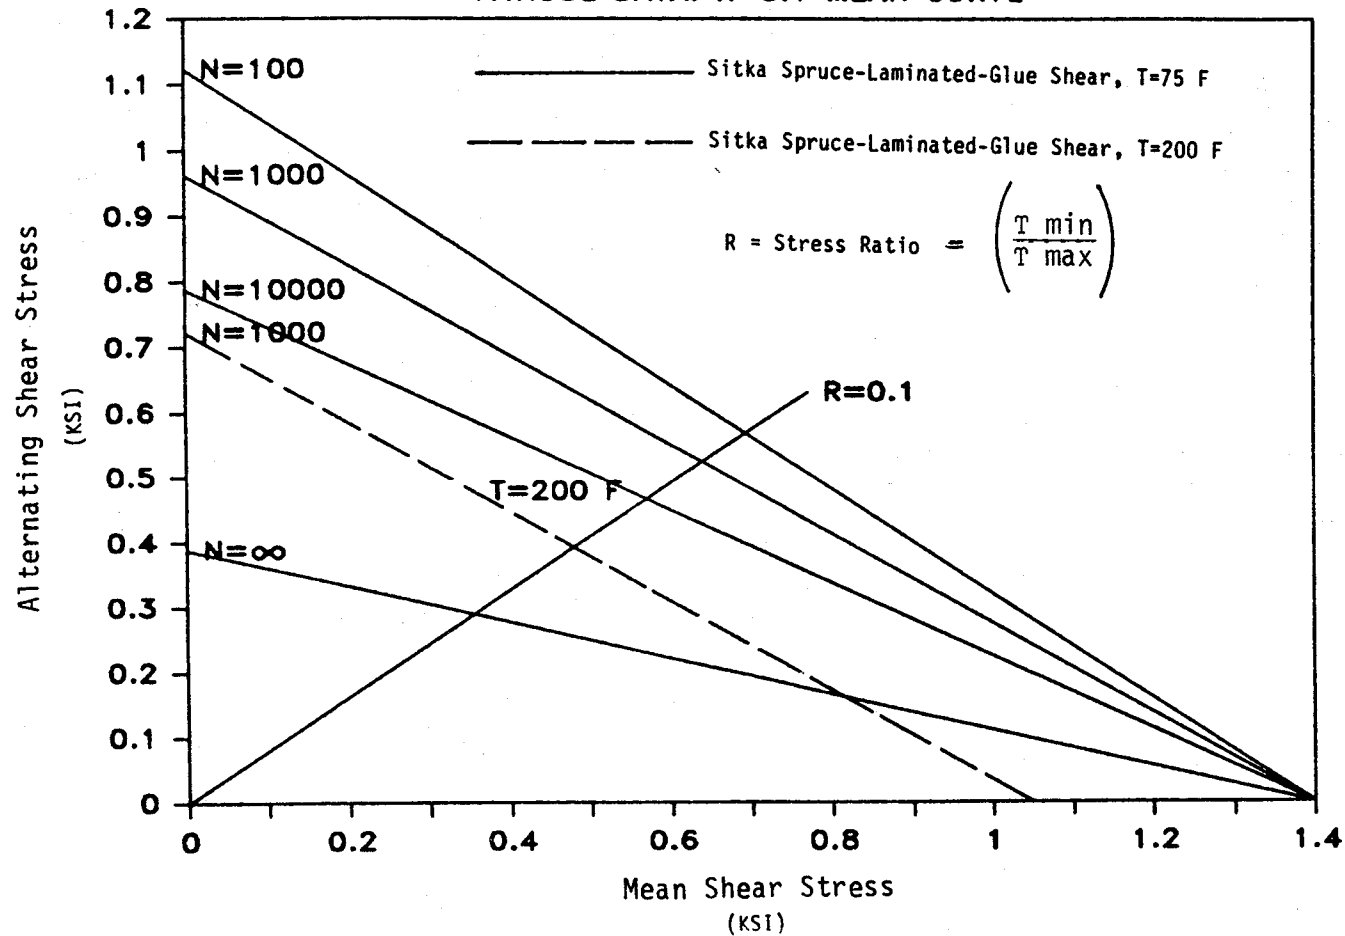
Figure 17. - Goodman Diagram for Laminated Sitka Spruce, Loaded in Shear

Application of fatigue data. - The consequences of operating with high stress for the 7- by 10-Ft blade were evaluated by performing a classical fatigue analysis using a S-N curve and modified Goodman diagram. A modified Goodman diagram for laminated Sitka Spruce loaded in shear is shown in figure 17.

Since most S-N curves will be developed for a single R value (minimum-stress/maximum-stress), the data may not be directly applicable to the stress cycles being analyzed. As previously stated, this difficulty may be accounted for by constructing a modified Goodman diagram. This diagram is constructed by plotting the fatigue strength (alternating stress component for a given number of cycles) on the R ratio ray, from the given S-N curve, and projecting from these points to the ultimate strength (maximum mean stress with zero alternating component). By doing this for each value of cycles to failure (N), then constant life curves may be constructed as shown on figure 19. Figure 19 illustrates the fatigue life predictions for the old and new design of the 7- by 10-Ft blades. This figure shows the points on the diagram relating to operational and 2 per/rev. cycles. As can be seen on the diagram the redesign resulted in an improvement in predicted life of almost two orders of magnitude.

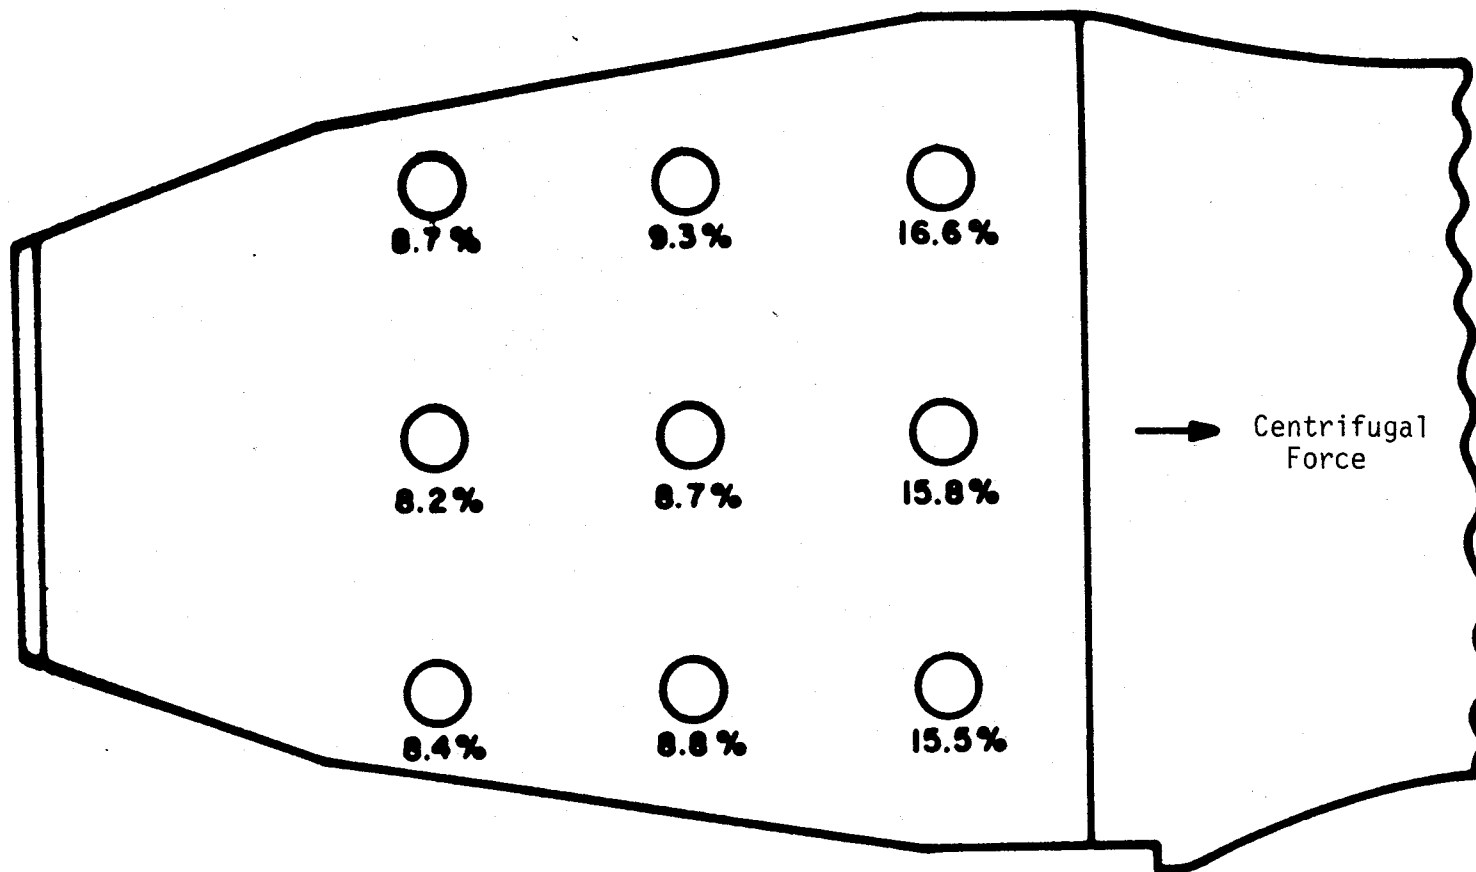
Figure 22. - Attachment bolt loads (% of total load) for the NASA Langley Research Center 16-Foot Wind Tunnel fan blades.

In the past, simple hand calculations were performed to determine several critical stresses in a fan blade. The average tensile stress was determined using the centrifugal force and the minimum cross-sectional area of the blade. The maximum shear stress was determined using the minimum shear out area in the bolt region of the blade butts. Both of the stresses were nominal stresses and did not represent the true peak stresses in the blade. With today's finite element programs, a very detailed stress distribution can be estimated. Both the 7- by 10- and 16-Ft High Speed Wind Tunnel fan blades at LaRC were analyzed with finite element models. These models included details of the blade geometry, orthotropic properties of the wood, and were sufficient to determine the stress distributions around each of the bolt holes in the blade butts. A description of the analytical results for the 7- by 10-Ft High Speed Wind Tunnel is presented in reference 26. Aerodynamic loadings, centrifugal forces, moisture changes, and thermal stresses were simulated in these models. Several interesting results were obtained from these models. For both tunnels the bolt or pin loads varied significantly as shown in figures 21 and 22. In addition for the 7-by 10-Ft Wind Tunnel blade butt, the stress contours below the minimum area did not expand back out to the full thickness of the blade butt. This effect further concentrated the nonuniform bolt loading. For the 16-Ft Transonic Wind Tunnel blades, moisture changes produced significant stresses in the bolt hole region. The insights gained from these analyses were used to improve the design of the new blades for each of these tunnels.

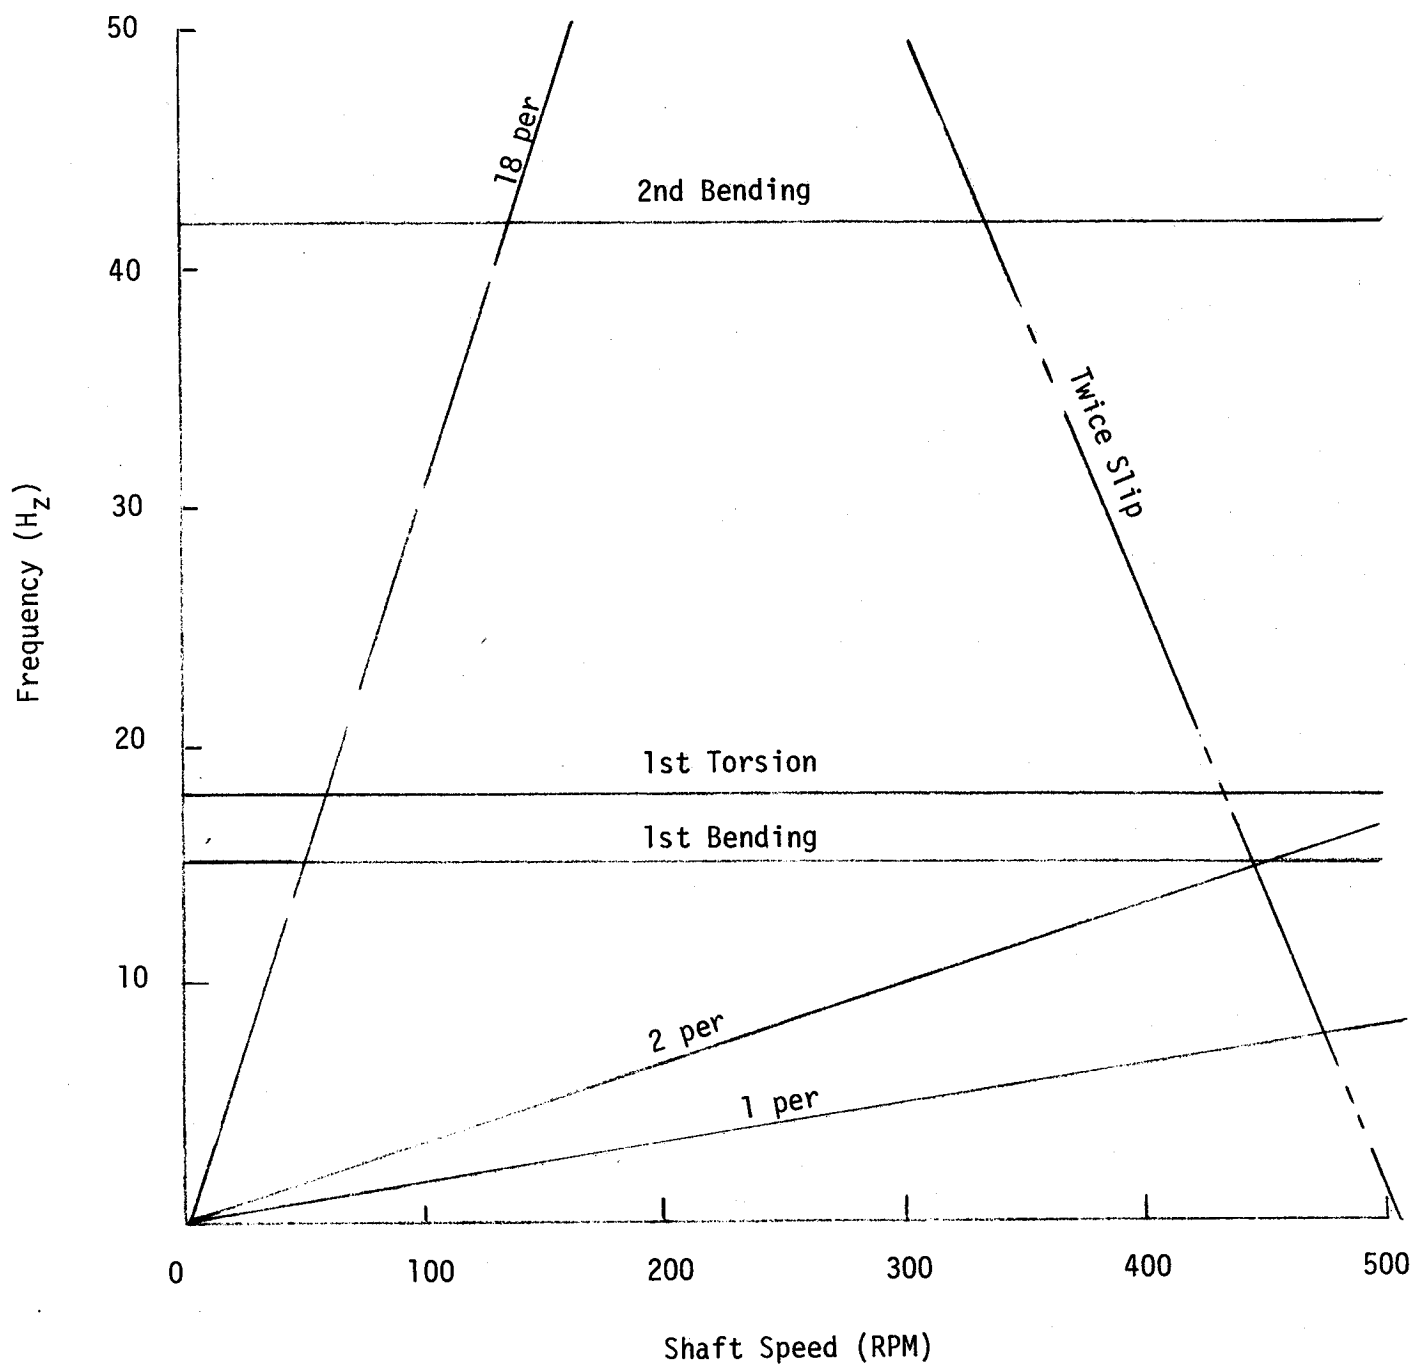
Figure 23. - Interference (Campbell) Diagram for NASA Langley Research Center High Speed 7- by 10-Foot High Speed Wind Tunnel.

Avoidance of resonance conditions is very important for long life. Use of an Interference Diagram during design is very useful in doing this. There can be several aerodynamic and electrical forcing functions. A sample diagram is given in figure 23. This is for the fan in the LaRC High Speed 7- by 10-Ft Wind Tunnel. Several forcing functions are shown as well as several natural frequencies. Potential resonance points occur at the intersections of the curves. In most cases the forcing functions are very weak at the intersection, so resonance is not a problem. Usually the most important for wooden wind-tunnel fans is the first bending and a once per revolution forcing function (i.e. one per rev curve in the figure). For the example shown, intersection of the one per and first bending mode does not occur.
